Skydio X10 and X10D

OSB Number: SOSB-24-V09

Date: 17 September 2024

Safety Risk: In extremely rare cases, a motor may draw a disproportionate amount of current, resulting in motor failure and potential loss of vehicle control or crash.

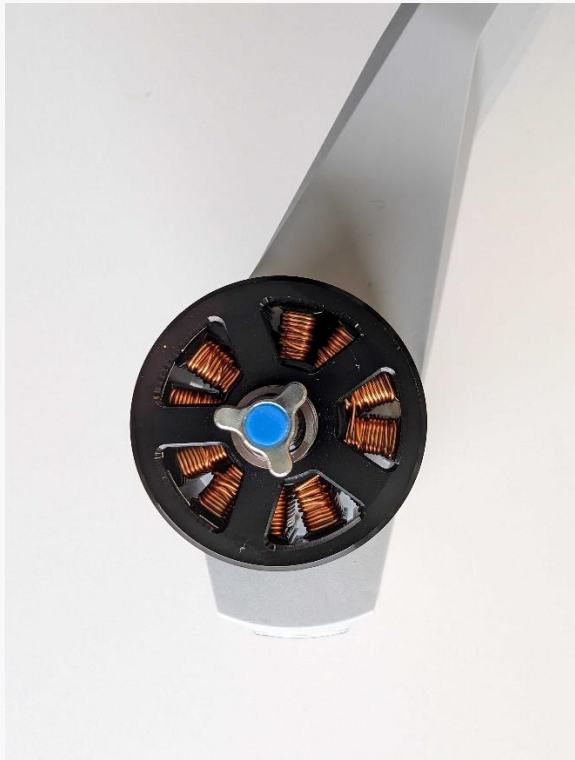
Healthy motor stator tooth

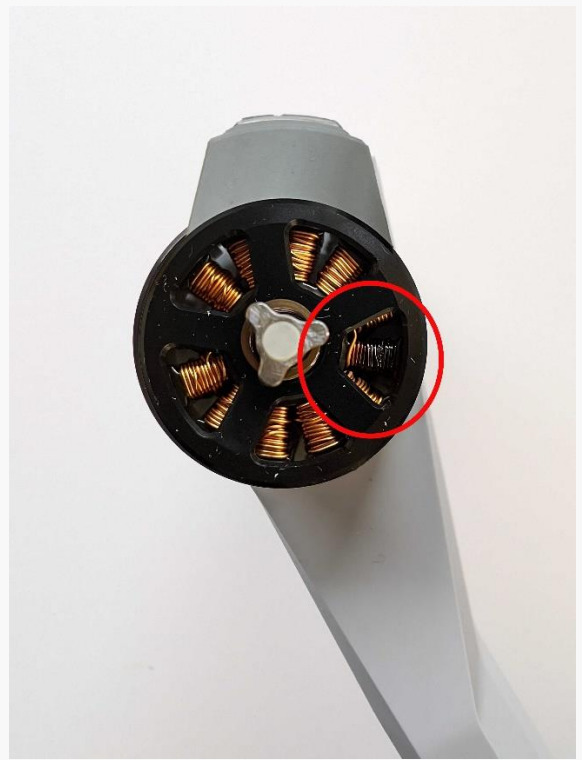
In an extremely small number of cases, Skydio has identified charring on motor stator windings, which may occur when a motor draws excessive power. While this issue is extremely rare, we encourage pilots to inspect motors before flight as a precaution.

Increased current saturation may lead to sluggishness and potentially total motor failure during flight.

In a properly functioning propulsion motor stator, operating under nominal conditions, the copper wires should be free of cuts or other damage and evenly colored. However, if you observe any signs of charring or notice that the tooth of a stator appears black compared to the others, this could indicate an issue related to increased power draw. The enamel coating on the wire may also appear to warp or blister, which can be a precursor to charring. In such cases, please contact BSSHolland.

Damaged motor stator tooth

In an upcoming software release, Skydio will implement a dismissible prompt that appears if excess current draw on a motor is detected. If this prompt appears, we strongly recommend landing and contacting BSSHolland.

- Always conduct thorough preflight inspections
 - Inspect the wiring in the motor for signs of overheating, such as discoloration, a burnt odor, or blistering/warping of the wire enamel, which may indicate exposure to excessively high temperatures driven by current
- If any wiring appears abnormal do not launch
- BSSHolland for replacement
