## FIELD SERVICE BULLETIN

SUBJECT: Time of Flight (TOF) GPS Signal Loss

FSB NUMBER: FSB-00001

Teal Part: Golden Eagle

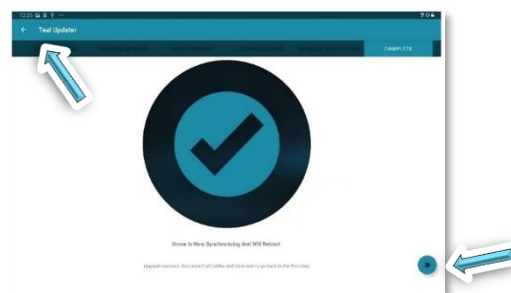
- The system will then reboot the drone. Once the reboot is complete, the update process is complete.

Select either the EXIT button to return to the Teal QGC, or, select NEXT to go back to the beginning of the upgrade wizard to verify the new firmware version on the drone.
